# Blokzijl Baptist Church

## ClimateCoating® ThermoPlus

Dehumidification for walls exposed to salt

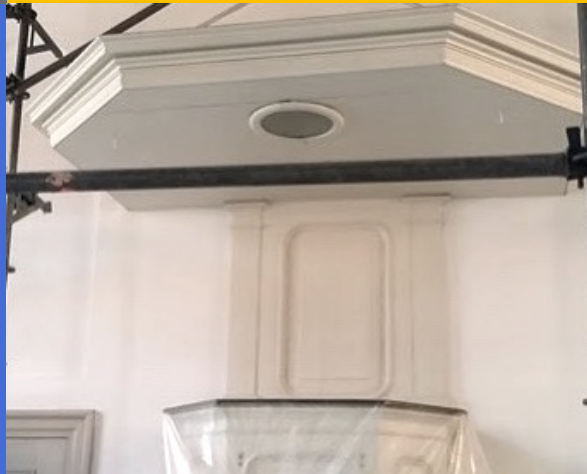
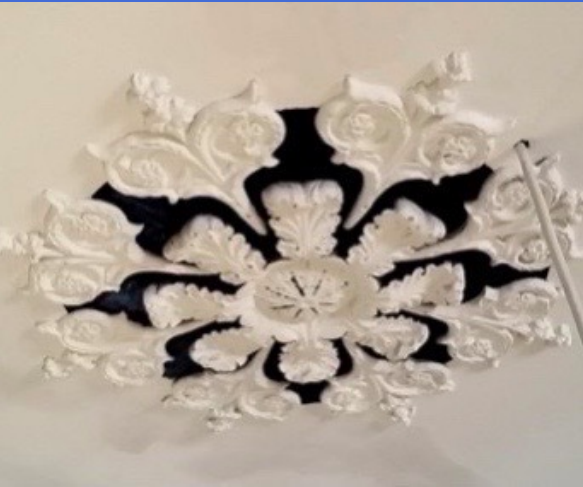
The Baptism Church (Doopsgezinde Kerk) was built around 1850. The mighty brick walls, clinker on the outside and plastered on the inside, have a damp problem.

The walls are damp and contaminated with salt. They were renovated in 1990, but the result was unsatisfactory, with the paint peeling off in many places after just two weeks.

In the course of the 1990s, the problems increased, cracks appeared and the paint peeling increased.

In 2001, a coating was applied with the product **ClimateCoating® ThermoPlus** (2x on the FixPlus primer after removal of the chalking old coating).

**ClimateCoating® ThermoPlus** remained stable on the walls and dehumidified them: Measurements showed a reduction from 85 to 62 units within three months.
